**ADULT PACIFIC LAMPREY PASSAGE AT THE FOUR LOWER COLUMBIA RIVER
DAMS AND LAMPREY BEHAVIORS IN RELATION TO NIGHTTIME FISHWAY
VELOCITY REDUCTIONS AT BONNEVILLE AND THE DALLES DAMS AND THE
NEW UMTJ-LPS AT BONNEVILLE DAM - 2019**

Study Code: LMP-P-17-1

U.S. Army Corps of Engineers
Portland District

Technical Report 2020-1

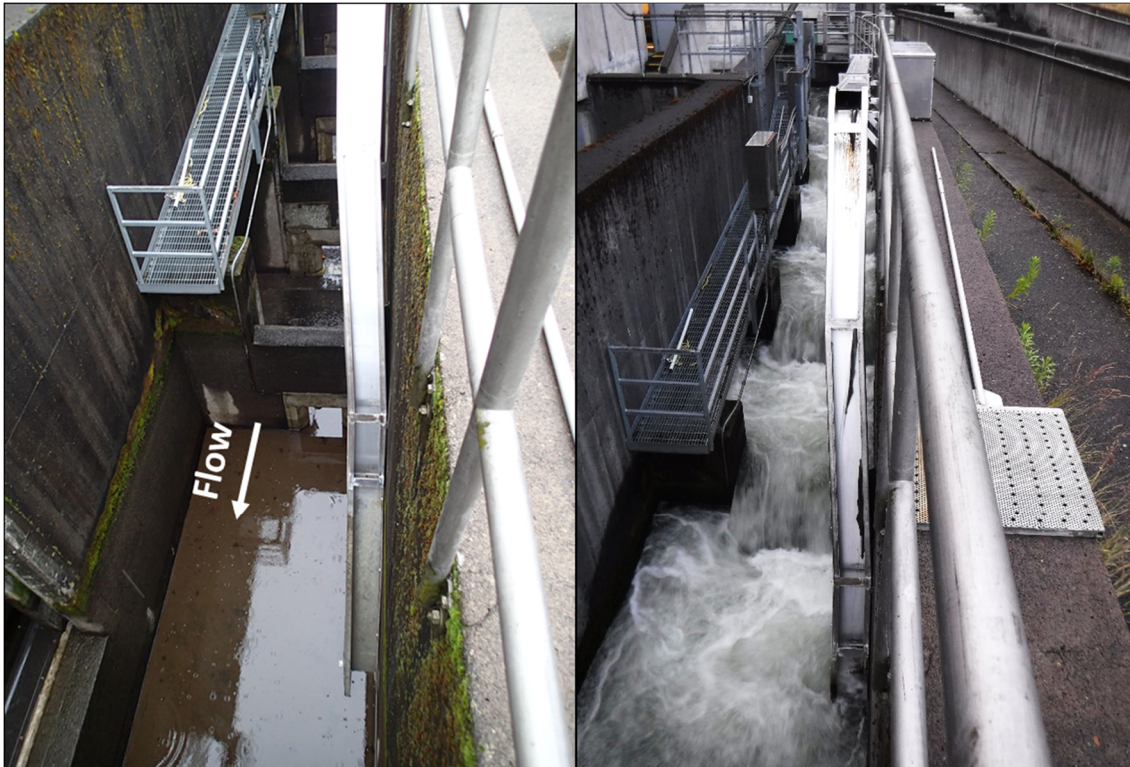
Figure 1. Overhead view of Adult Fish Facility (AFF) lamprey trap dewatered (left) and in operation (right) in the Washington-shore fish ladder at Bonneville Dam.

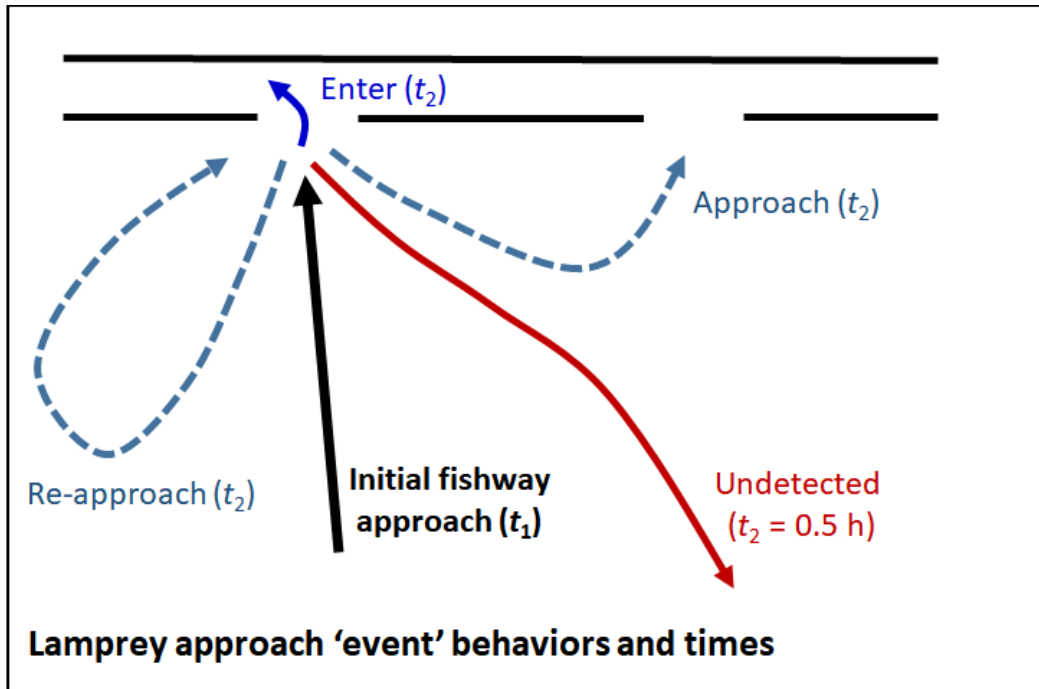
Figure 9. Schematic of a lamprey approaching a fishway opening and subsequent behaviors. Each approach event could be followed by one of four behaviors: 1) fishway entry; 2) fishway approach at another opening at the same fishway; 3) re-approach at the original opening; and 4) no further detection at the fishway within 30 minutes of the initial fishway approach.

increase the proportion of lampreys that entered the fishways and to reduce the amount of time between fishway approach and fishway entry events. The analyses required several elements because lamprey behaviors around the fishway openings were sometimes complex, with many individual lampreys approaching, entering, and exiting the fishways multiple times. In addition, individual fish and individual passage attempts, or ‘events’, could potentially include lamprey exposure to both fishway velocity treatments. We therefore structured most of the analyses at the event scale (e.g., Keefer et al. 2012, 2013b), which incorporated treatment conditions at the start and end of each event (Figure 9).

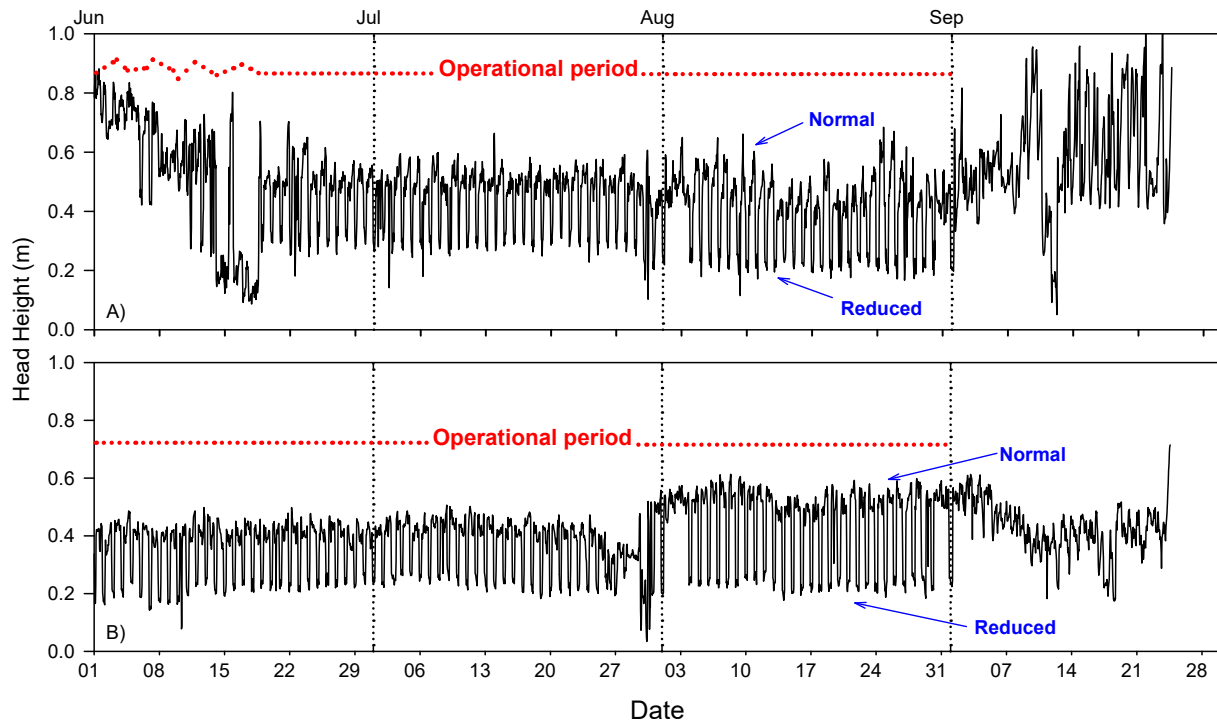
Figure 10. Head height (m) measured with water level loggers (mean hourly) inside and outside the A) Bradford Island B-Branch (spillway) and B) Bradford Island Powerhouse 1 entrances during normal and reduced velocity conditions throughout the study period (1 June to 31 August) at Bonneville Dam in 2019.

Fishway entrance head was reduced nightly at Bonneville Dam and the experimental manipulation of fishway entrance head levels was successful at The Dalles east ladder (Figures 10 and 11). During the study period at Bonneville Dam, entrance velocities were reduced nightly (22:00 – 04:00, 1 June – 31 August), and the reduced velocity occurred 91% (Powerhouse 1) and 84% (B-Branch) of the nights (Table 2). When daytime hours were included, the reduced condition at Bonneville occurred 25-29% of the time. Randomized reduced treatments at The Dalles Dam occurred on 16% of nights during the experimental period and 5% of the total combined day and night hours.

The water level logger data indicated that conditions near the B-Branch entrance at Bonneville Dam were more seasonally variable than at the Powerhouse 1 entrances, likely reflecting effects of spillway discharge and higher turbulence in the spillway tailrace. Additionally, nighttime reduced velocities were not consistently achieved at the B-Branch entrance until ~18 June. Water levels also fluctuated somewhat at the east fishway opening at The Dalles Dam, where some reduced treatment conditions were less pronounced than others. The variation added some uncertainty to the treatment assignments and experimental evaluation (Figure 11).

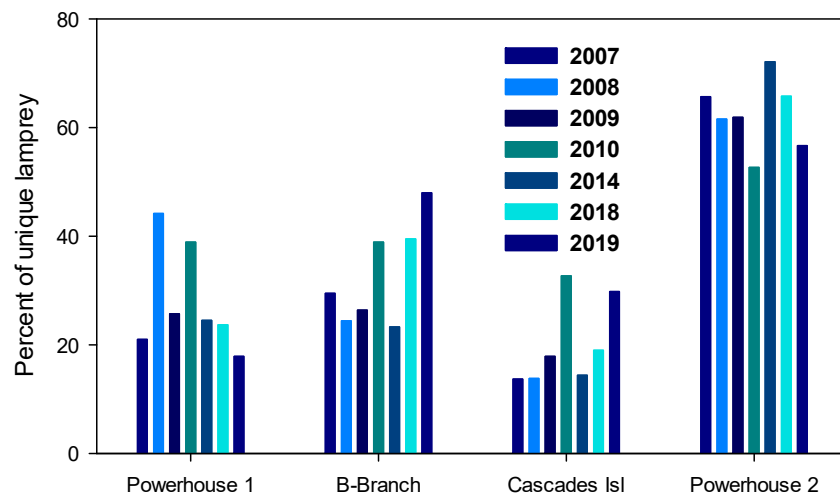
Figure 12. Percentage of unique lamprey (unique lamprey approaches at each site/all first approaches) at Bonneville Dam fishway entrances in 2007-2010, 2014, and 2018-2019.

Among the 379 double-tagged lampreys that approached Bonneville Dam in 2019, 17% ($n = 64$) made at least one approach at Powerhouse 1 and 48% ($n = 179$) made one at the B-Branch entrance (Figure 12). Among previous study years, 2019 had the lowest percentage of fishway-approaching lamprey make an approach at PH1 and the highest percentage make an approach at the B-Branch opening.

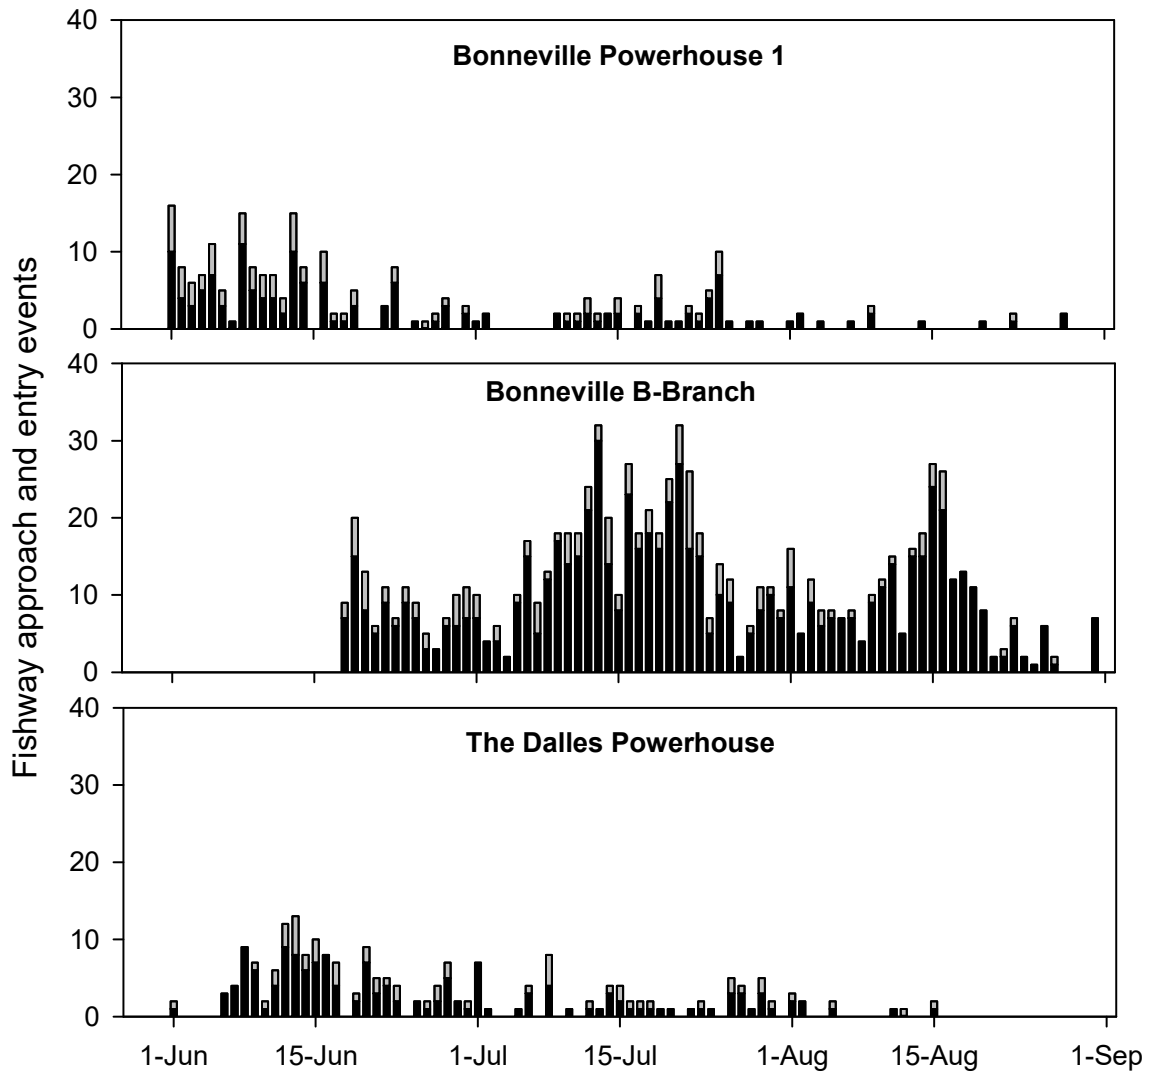
Figure 13. Numbers of fishway approach (black shaded area of bars) and fishway entry (gray shaded area of bars) events by double-tagged adult Pacific Lampreys during the nighttime fishway velocity reductions at Bonneville Dam and velocity experiments at The Dalles Dam in 2019.

Lampreys approached and entered fishways throughout the nighttime velocity reduction period, although activity tapered off in August at Bonneville Powerhouse 1 and at The Dalles Powerhouse (Figure 13). Most of the lamprey activity near the fishway entrances occurred at night (Figure 14).

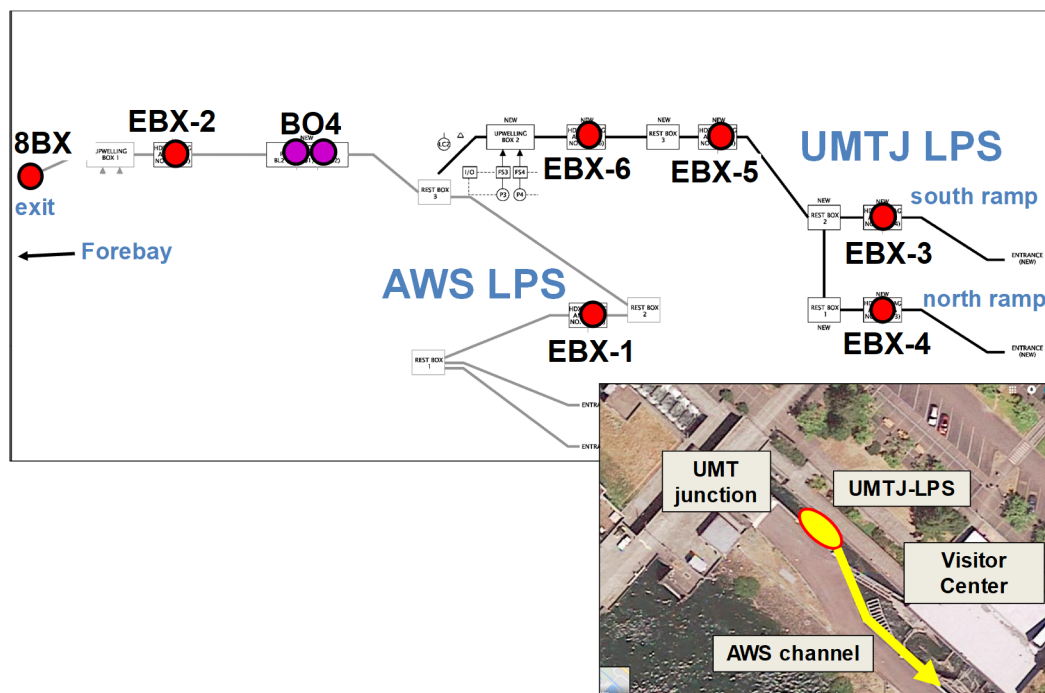
Figure 23. Map of UI (●, *BX-# labels), and PTAGIS HD PIT antennas (●, BO4) in the Washington-shore LPSs (UMTJ-LPS and AWS-LPS) in 2019.

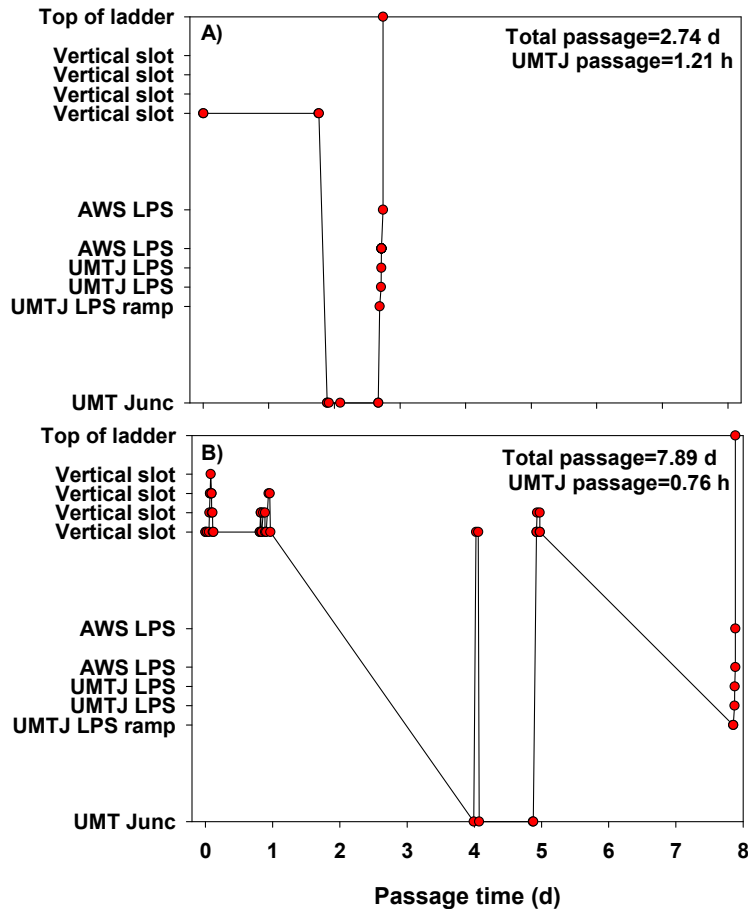
Figure 24. Examples of PIT-tagged lamprey movements and passage times inside the WA-shore fishway before they passed via the UMTJ-LPS. Passage dates were A) 31-July and B) 19-June in 2019. Y-axis labels correspond to locations of individual PIT antennas, ordered from downstream to upstream and ‘vertical slot’ = serpentine weir.

were 0.2 d ($n = 3$) for fish that used the UMTJ-LPS, 0.8 d for fish that used the AWS-LPS ($n = 20$), and 1.1 d for fish that used the ladder ($n = 15$). For the other three fish that used the UMTJ-LPS but were initially detected in the vertical slot weirs (i.e. missed detection at UMT junction; Figure 24) median total passage time was 7.9 d ($n = 3$).

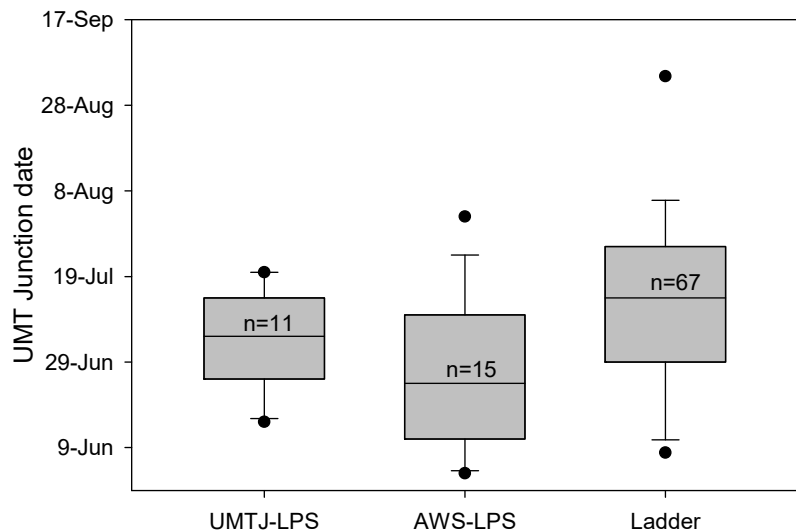
Figure 25. Box plots of first UMT junction date for double-tagged lampreys that passed Bonneville Dam via three routes at the WA-shore fishway. Distributions show 5th, 10th, 25th, 50th, 75th, 90th, and 95th percentiles.

PIT and double-tagged lampreys – Similar proportions of PIT- and double-tagged lampreys passed the dam ($\chi^2 = 0.69, P = 0.407$). PIT- and double-tagged lampreys were more likely to pass the dam via the ladder than via LPS routes ($n = 192, \chi^2 = 9.94, P = 0.001$). Among lampreys that passed the dam, route use for PIT-tagged lampreys was 6.1% UMTJ-LPS, 35.3% AWS-LPS, and 58.6% ladder and was 11.8%, 16.1%, and 72.1%, respectively, for double-tagged lampreys. There were no differences in lamprey size metrics among routes (UMTJ-LPS, AWS-LPS, ladder) for PIT or double-tagged lampreys (ANOVA, all $P > 0.05$). However, migration date (first detection at UMT junction) differed among routes for double-tagged lampreys ($df = 2, F = 4.53, P = 0.013$), where the average date of ladder use was later in the season (Figure 25).

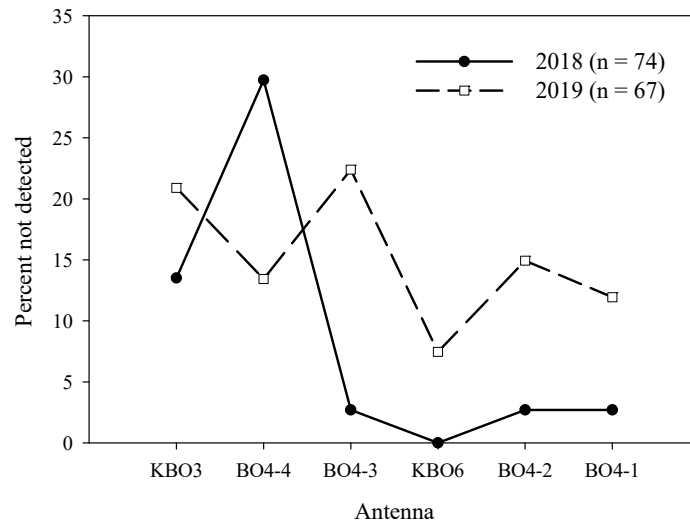
Figure 30. Percent of ‘missed’ detections on south-side radio antennas and on the vertical-slot BO4 PIT antennas by double-tagged Pacific Lampreys that successfully passed Bonneville Dam via the WA-shore serpentine weirs in 2018 and 2019. PIT antennas: BO4-1 - BO4-4; radio antennas KBO3 and KBO6 were on the south side of the fishway. Antennas are ordered from downstream to upstream. Lower detections among passing lamprey during 2019 than 2018, particularly on upstream antennas, is consistent with use of the lamprey slot orifices.

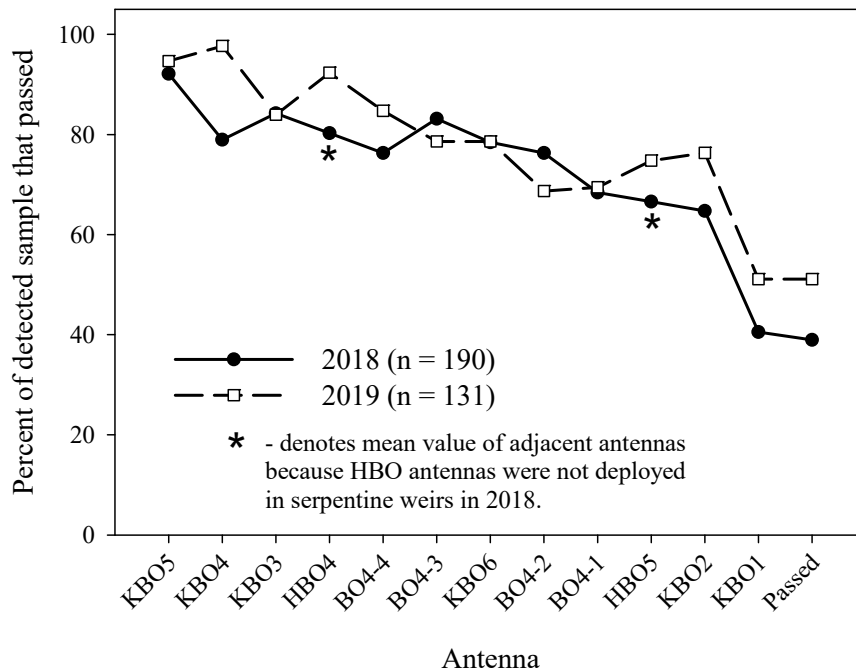
Figure 31. Percent of double-tagged adult Pacific Lampreys detected on south-side radio antennas and on the vertical-slot BO4 PIT antennas that successfully passed Bonneville Dam via the WA-shore serpentine weirs in 2018 and 2019.
